WHITE'S POND DAM

PHASE I INSPECTION REPORT

NATIONAL DAM SAFETY PROGRAM

NJ00233

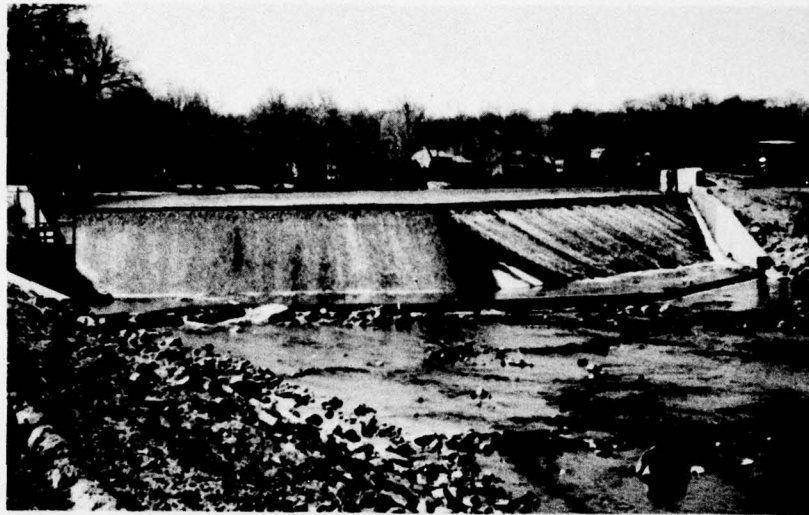
Photo 1 - View of dam from downstream; low level outlet facilities are on the left side of picture (right abutment)

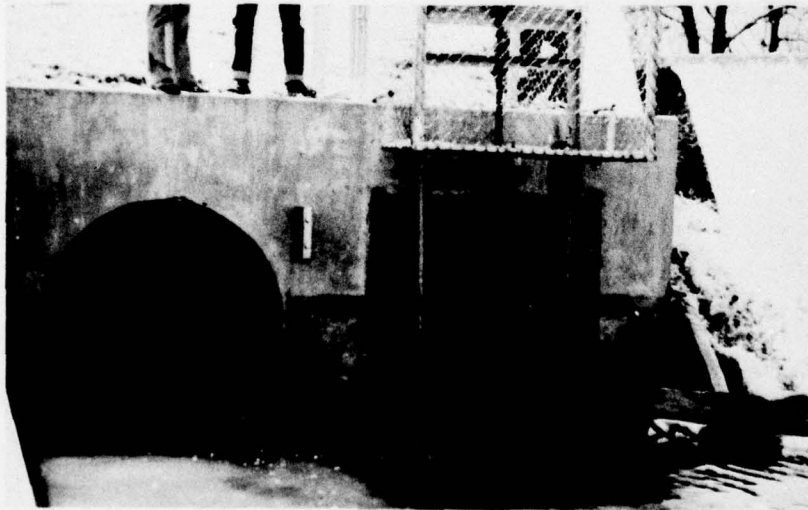
There was a leak of approximately 10 gpm coming from between the sluice gate frame and the face of the concrete spillway training wall extension to which the frame was anchored. No structural failure of anchor bolts or concrete could be found. The leakage is most likely due to failure of grouting or caulking compound.

Photo 2 - Close-up of downstream face of right abutment wingwall showing plugged 54-inch dia. diversion pipe used during construction, and face mounted 36-in. dia. low level outlet gate

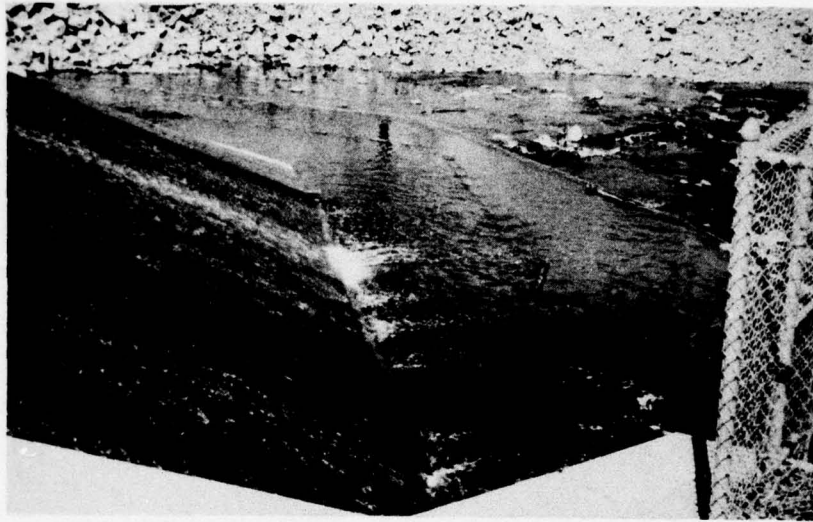
Photo 3 - View of the toe of the spillway and the stilling basin; the view is toward the left downstream channel bank; the 36-inch dia. low level outlet discharges into the stilling basin

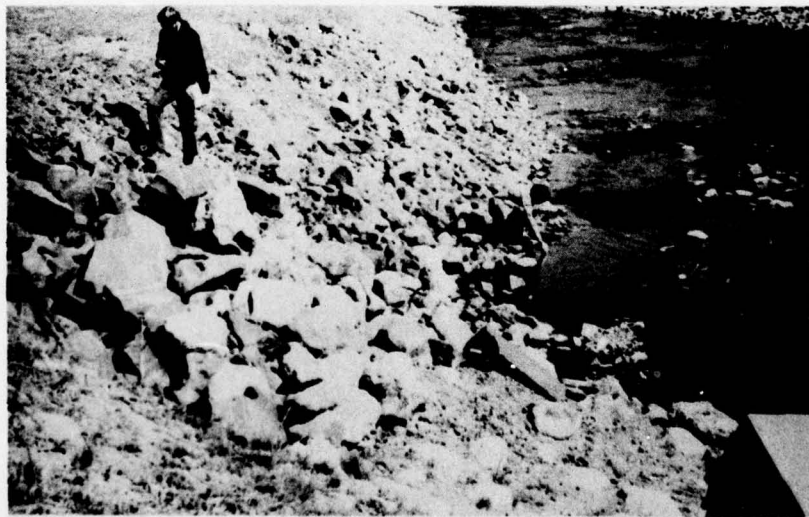
Seepage was observed coming out of the left channel bank, some 20 feet downstream of the end of the left spillway training wall and is 10 feet in lateral extent. The seepage volume is estimated at 1-2 gpm. The source of the water is thought to be the reservoir, passing through the left abutment.

Photo 4 - View of eroded area behind the left abutment wingwall; abutment seepage observed in the area of crouching figure, approximately 20 ft. downstream of end of spillway wingwall

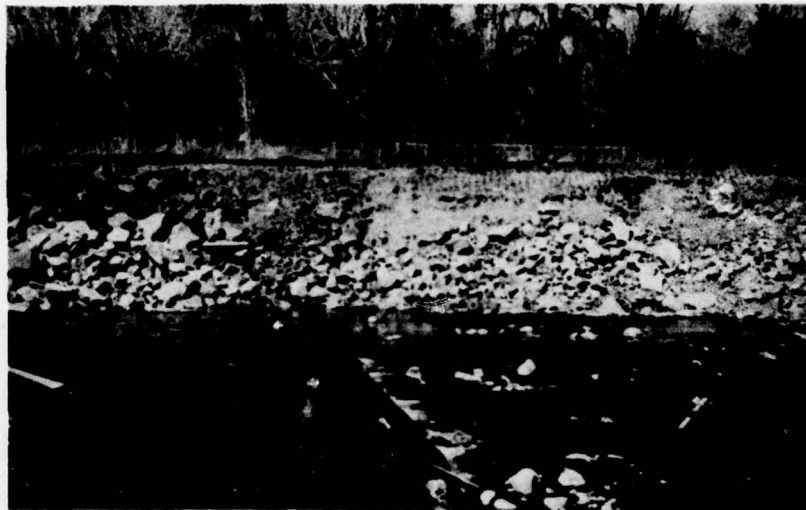
auxiliary spillway when the dam was overtopped, eroding the downstream channel bank riprap by undermining it. The resulting sloughing and slumping can be noticed in a local area 10-foot long. The poor geometric orientation of the left spillway training wall causes spillway water at high discharges to jump over the wall and erode the fill behind it. This action is potentially dangerous to the stability of spillway section and left abutment, if left uncorrected.

Photo 5 - View of damaged and slumping channel bank protection at the left channel bank caused by overtopping of the left abutment area by storm of November 7, 1977; the damaged area is at end of the stilling basin end sill visible in this picture

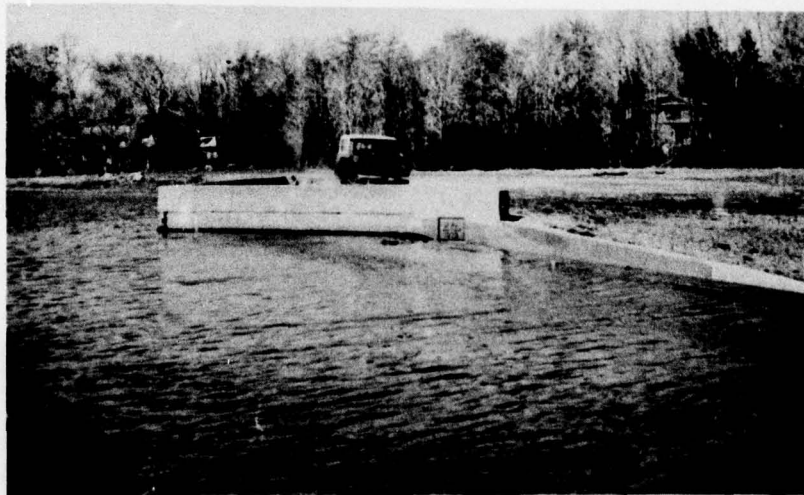
Photo 6 - View of the right abutment area overtopped on November 7, 1977, looking across the ungated weir crest and at the upstream abutment wingwalls

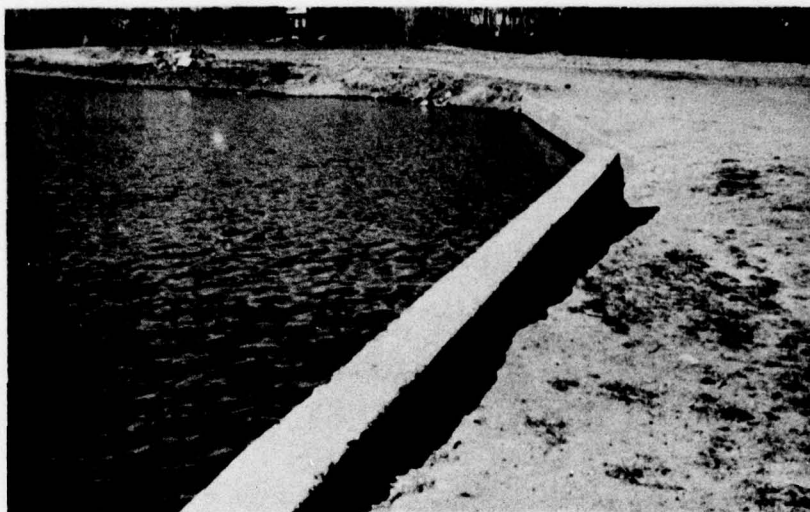
Photo 7 - View of left abutment upstream wingwall topped on November 8, 1977. The upstream shore of White's Pond can also be seen

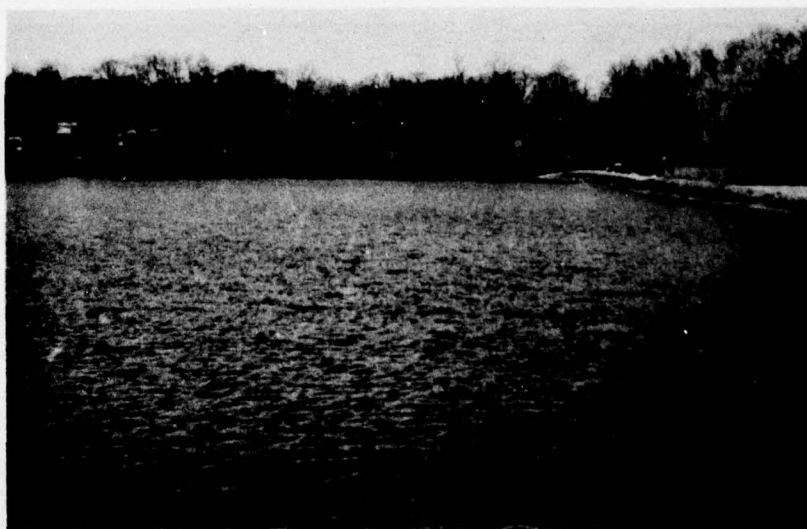
Photo 8 - View of White's Pond, looking toward the left shore line upstream of dam

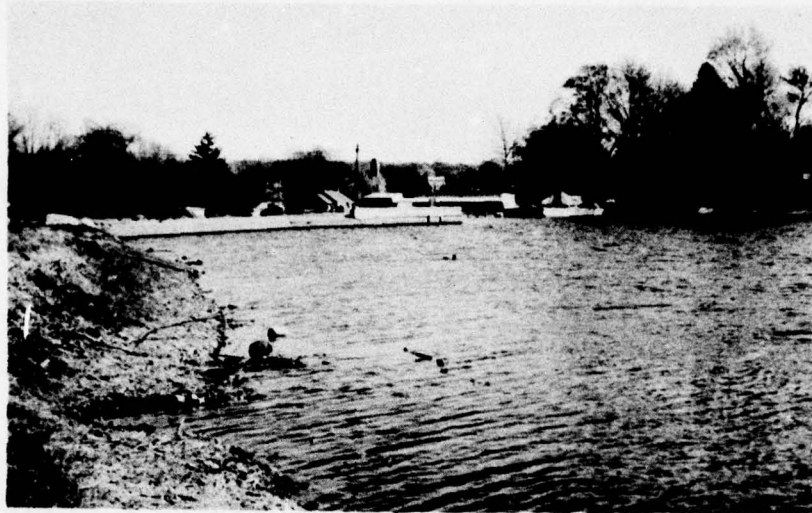
Photo 9 - Upstream face of the dam from left shore of White's Pond Dam

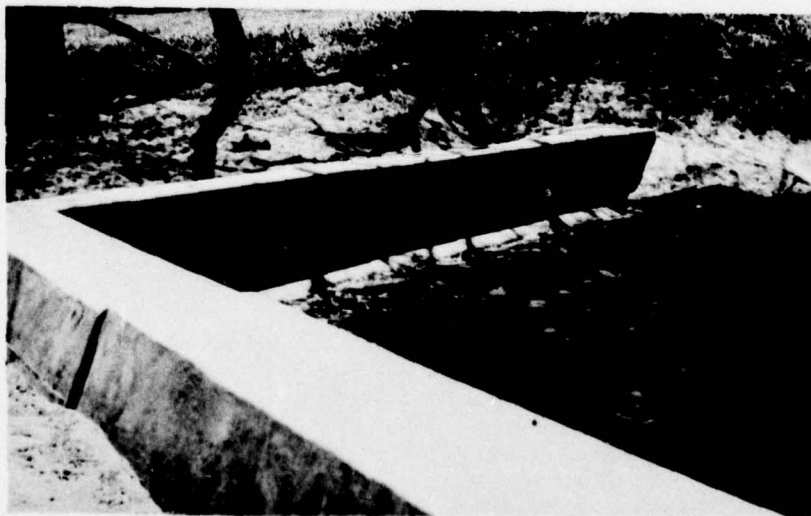
Photo 10 - Right abutment gravity cap wall added in the 1976 reconstruction; this wall was topped by one inch on November 7, 1977

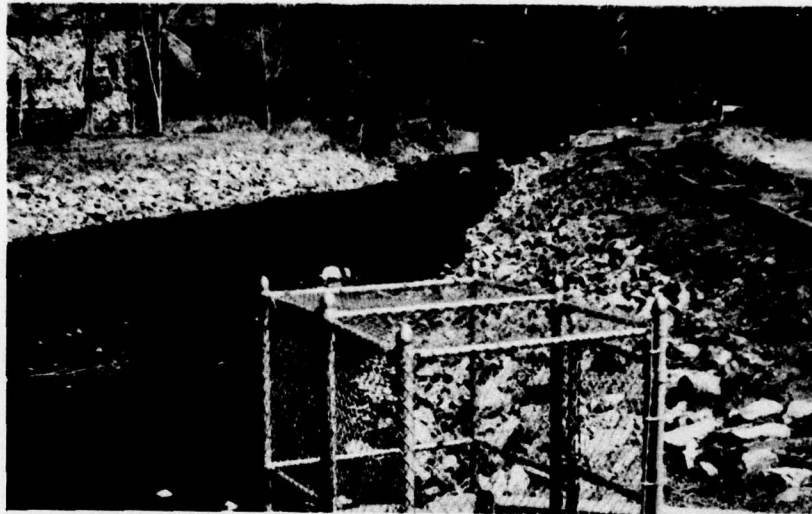
Photo 11 - View of downstream channel of Hohokus Brook; looking from right abutment area toward Hopper Avenue. The fenced enclosure in the foreground is to protect the 36-inch slide gate hoist stand on the low level outlet conduit.
